Manhole Inspection Summary

Manhole # S35Y1_010MH

Insp Date: **11/20/07 9:00 AM**

Location Address: **56 W. Talbott St.**

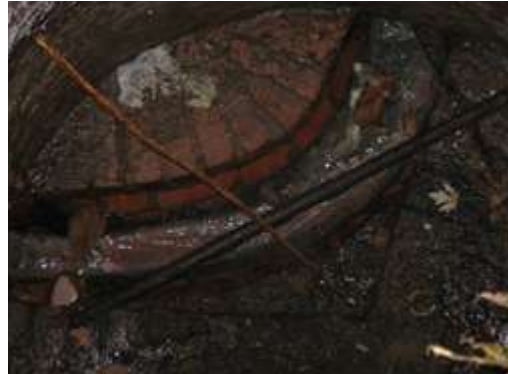
Defect 1

Large pole on bench

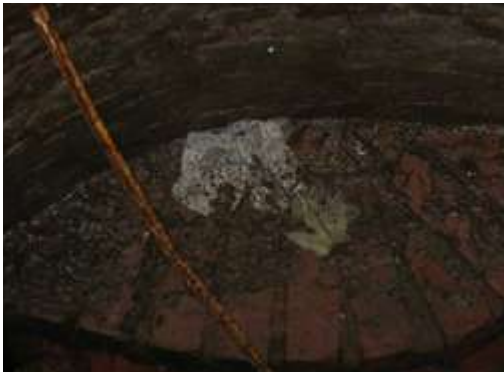
Defect 2

Surcharge ☒ **Evidence Of Surcharge** Depth: **6** (ft.) ☐ Active Surcharge Present

Evidence of Surcharge

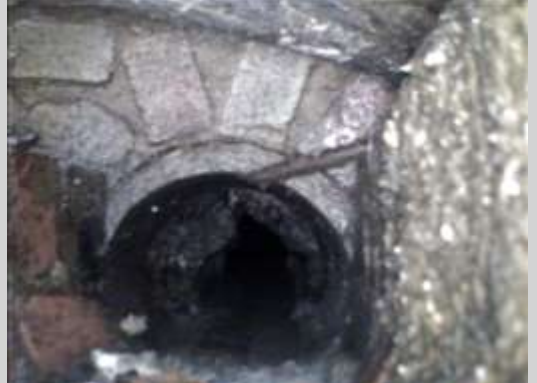
12 O'Clock Outflow

10 in. Circular Gravity Sewer
Pipe Out @ 12 O'Clock

Pipe Height: **9.6** (in.) Rod and Bar (Angled)
Pipe Material: **Clay** ☐ Pipe Lined
Invert Depth: **7.38** (ft.) Flow Characteristics: **Fast**
Deposits: ☐ None ☒ **Mud** ☒ **Sludge** ☐ Debris ☐ Grease
Silt Depth: **5** (in.) Deposits Extent: **Medium**
Infiltration: **None** Pipe Seal Cond: **Sound**

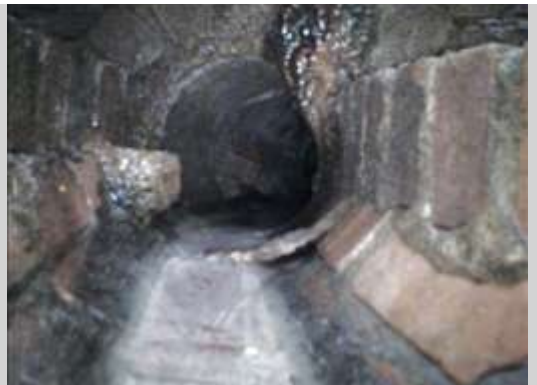
9 O'Clock Inflow

10 in. Circular Gravity Sewer
Pipe In @ 9 O'Clock

Pipe Height: **9.6** (in.) Rod and Bar (Angled)
Pipe Material: **Clay** ☐ Pipe Lined
Invert Depth: **7.04** (ft.) Flow Characteristics: **Fast**
Deposits: ☒ **None** ☐ Mud ☐ Sludge ☐ Debris ☐ Grease
Silt Depth: (in.) Deposits Extent:
Infiltration: **None** Pipe Seal Cond: **Sound**
